(11) Report on OPERATION REDWING, PROJECT 2.66b (U).

(6) CONTACT RADIATION HAZARD ASSOCIATED WITH AIRCRAFT CONTAMINATION BY EARLY CLOUD PENETRATIONS (U). (8)

(5) Air Force Special Weapons Center,
Kirtland Air Force Base, New Mexico

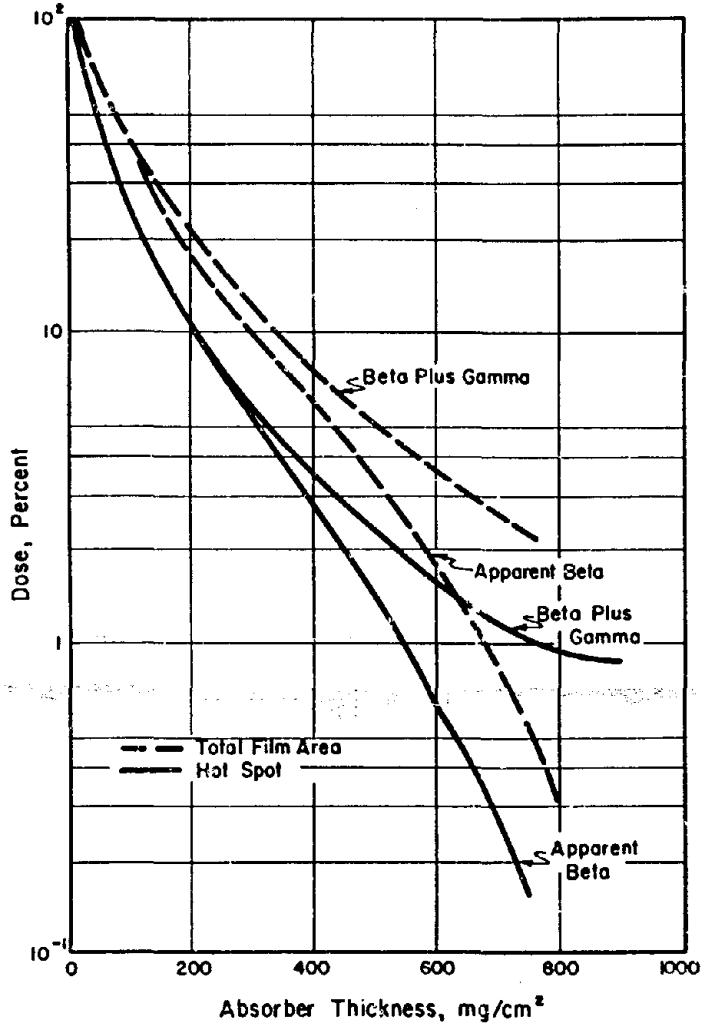
Figure 3.3 Depth-dose measurements on leading edge of B-57B.

Depth-dose measurements were made on the leading edge of the aircraft just inboard of the engine and, also, on the tip tank. These two positions were chosen in order to

allow a comparison between the apparent beta-gamma ratios near and at a greater distance from the stronger gamma field that exists at or near the jet engine.

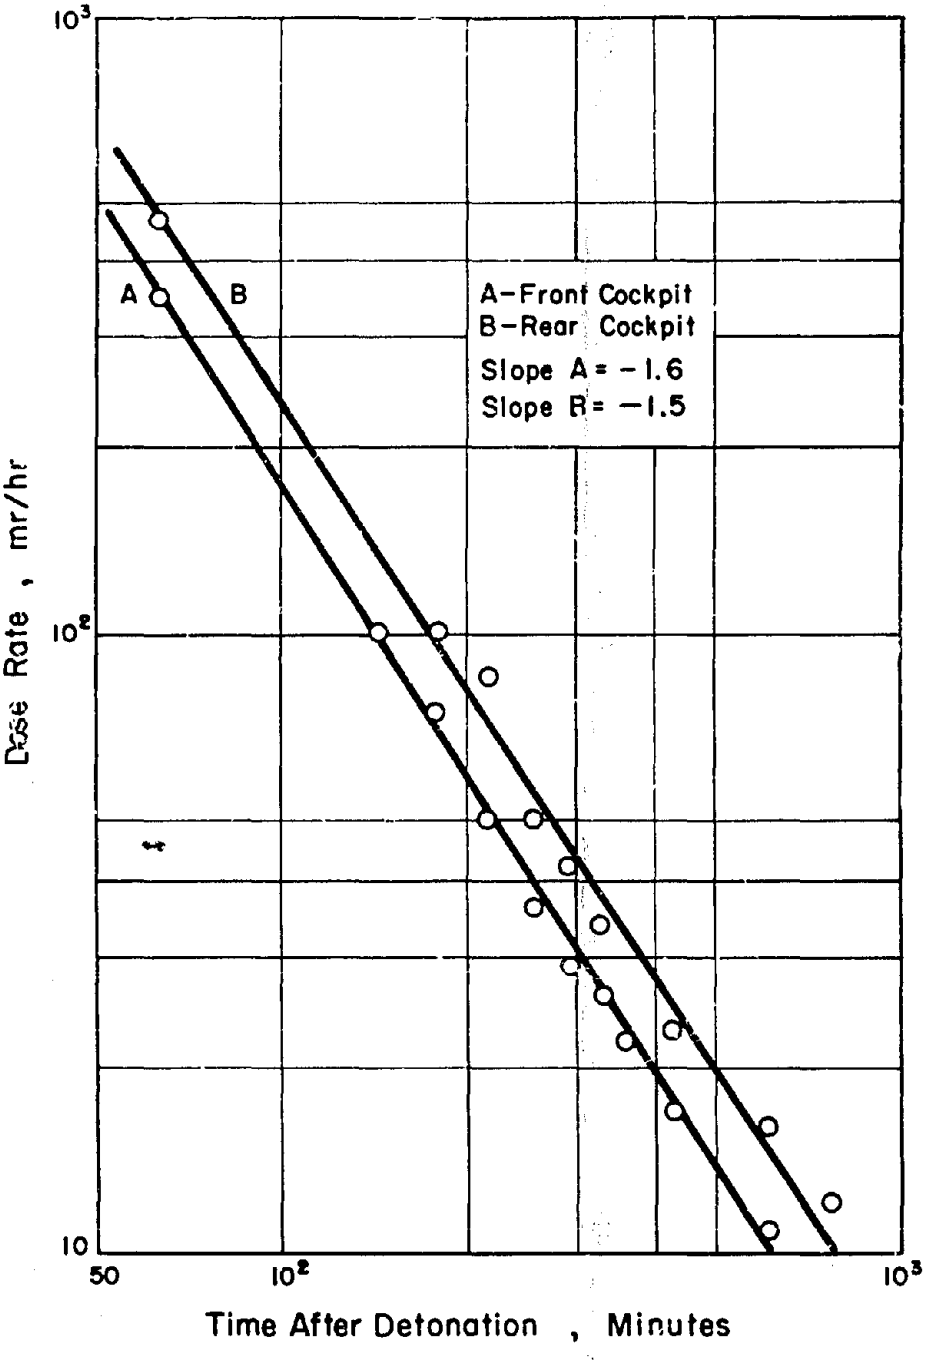
Figure 3.6 Decay of radiation dose rate in cockpit of contaminated aircraft, Shot Zuni, aircraft no. 527.

A record of the intensity of radiation in the crew compartments of the contaminated B-57's as measured by the T1B was kept. The measurements were begun as early as 90 minutes after detonation and continued for periods as long as 24 hours. The average slope of the decay curves was -1.6 with an average deviation of ± 0.4. A typical decay curve is shown in Figure 3.6. These decay curves are discussed more thoroughly in Reference 8.
